Technical Report

DEEP-OCEAN BIODETERIORATION
OF MATERIALS — PART VI. ONE
YEAR AT 2,370 FEET

U. S. NAVAL CIVIL ENGINEERING LABORATORY
Port Hueneme, California

Technical Report R-525

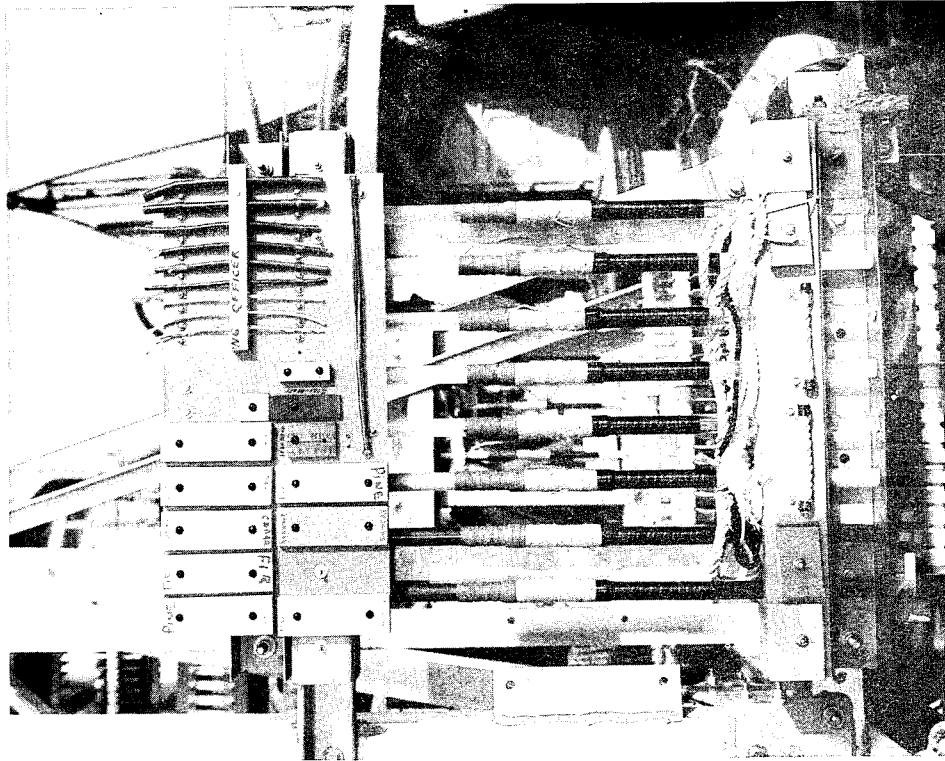
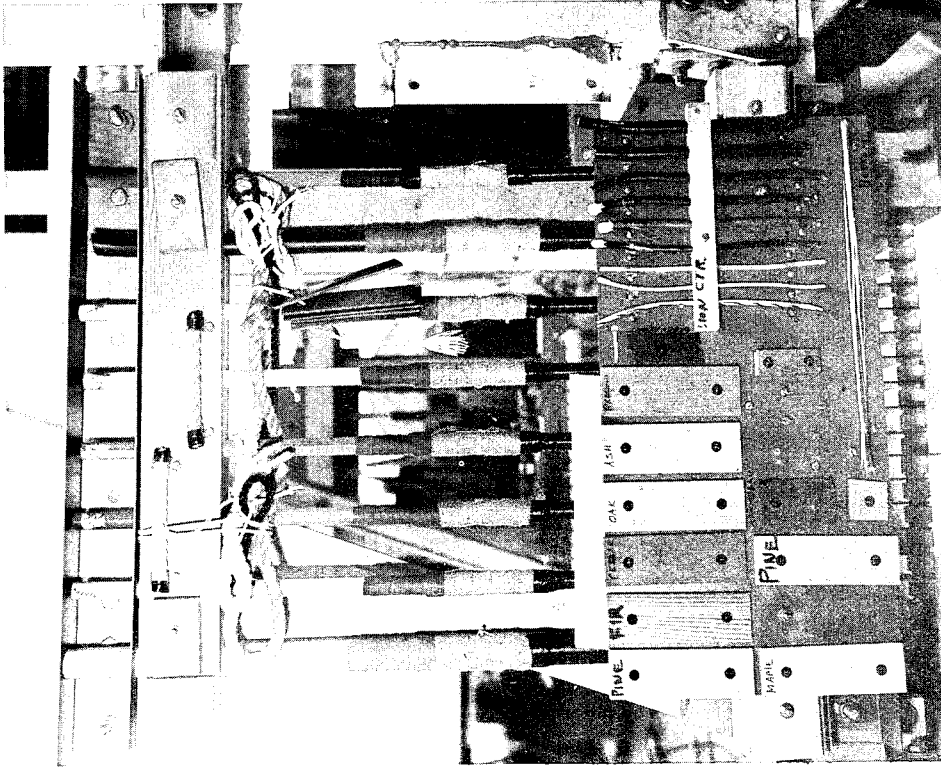
Figure 3. Various kinds of materials assembled in bio-racks before exposure.

(a) Wood panels at top of rack.

(b) Wood panels near sediment.

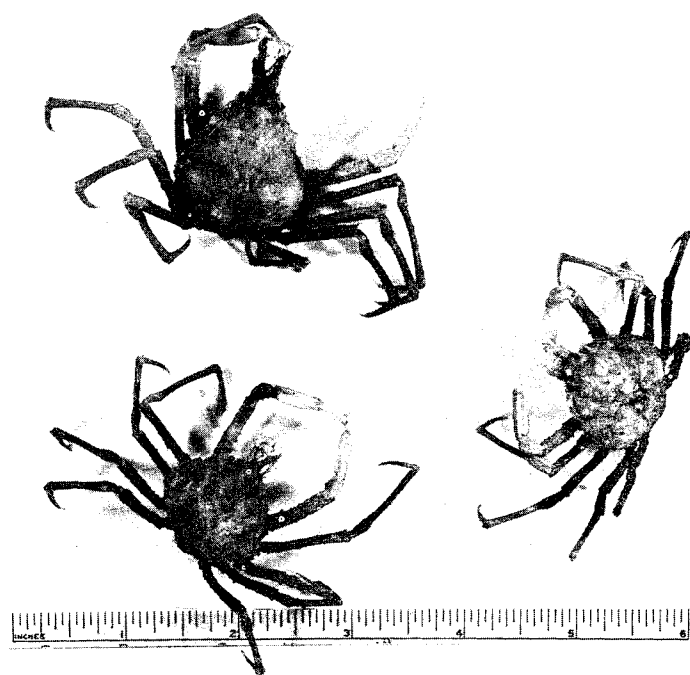
Several tubeworms (3-inch-long tubes made of mud and bottom debris) were found on stainless steel panels which were partially buried in the sediment (Figures 9 and 10). Another variety of tubeworms (tubes made of white calcareous materials) were found on stainless steel and titanium panels (Figure 11). A small pecten about 1/8 inch in diameter was also found attached to a titanium panel which was partially buried in the sediment (Figure 12). Several deep sea crabs (Figure 13), gastropods (Figure 14), and a large sea anemone (Figure 15) were found on various test panels.

Figure 13. Deep sea spider crabs.

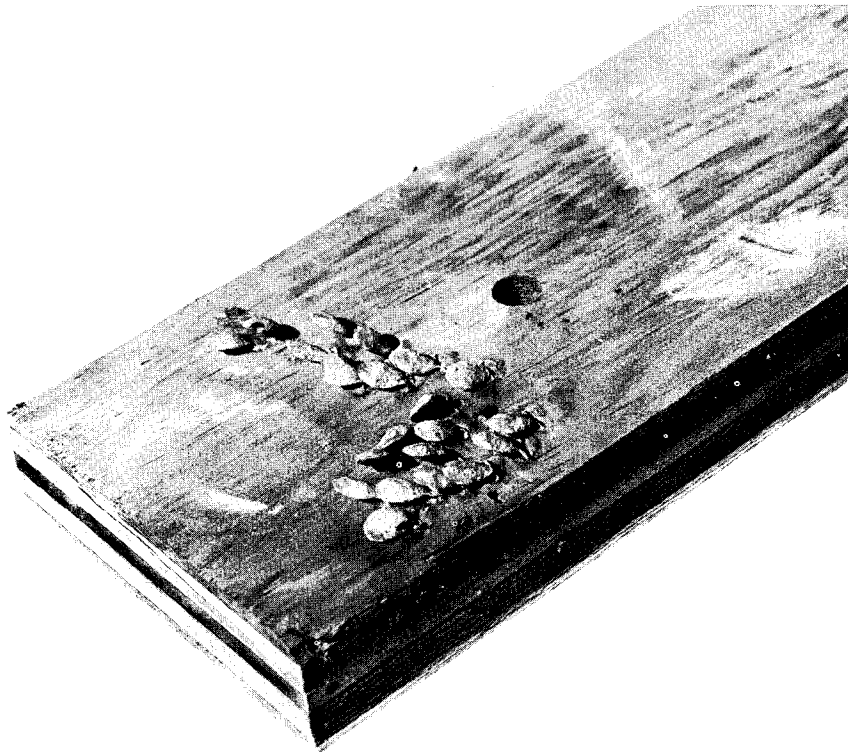
A 3/4x3x36-inch untreated plywood specimen was exposed between 5 and 8 feet above the mud line. As expected, the damage by the borers was very light compared to wood exposed near the mud line (Figure 23). At the lower end of the plywood board were attached clusters of egg sacks of some unknown marine animals (Figure 24).

Figure 24. Cluster of egg cases of unknown animal attached to a plywood board.

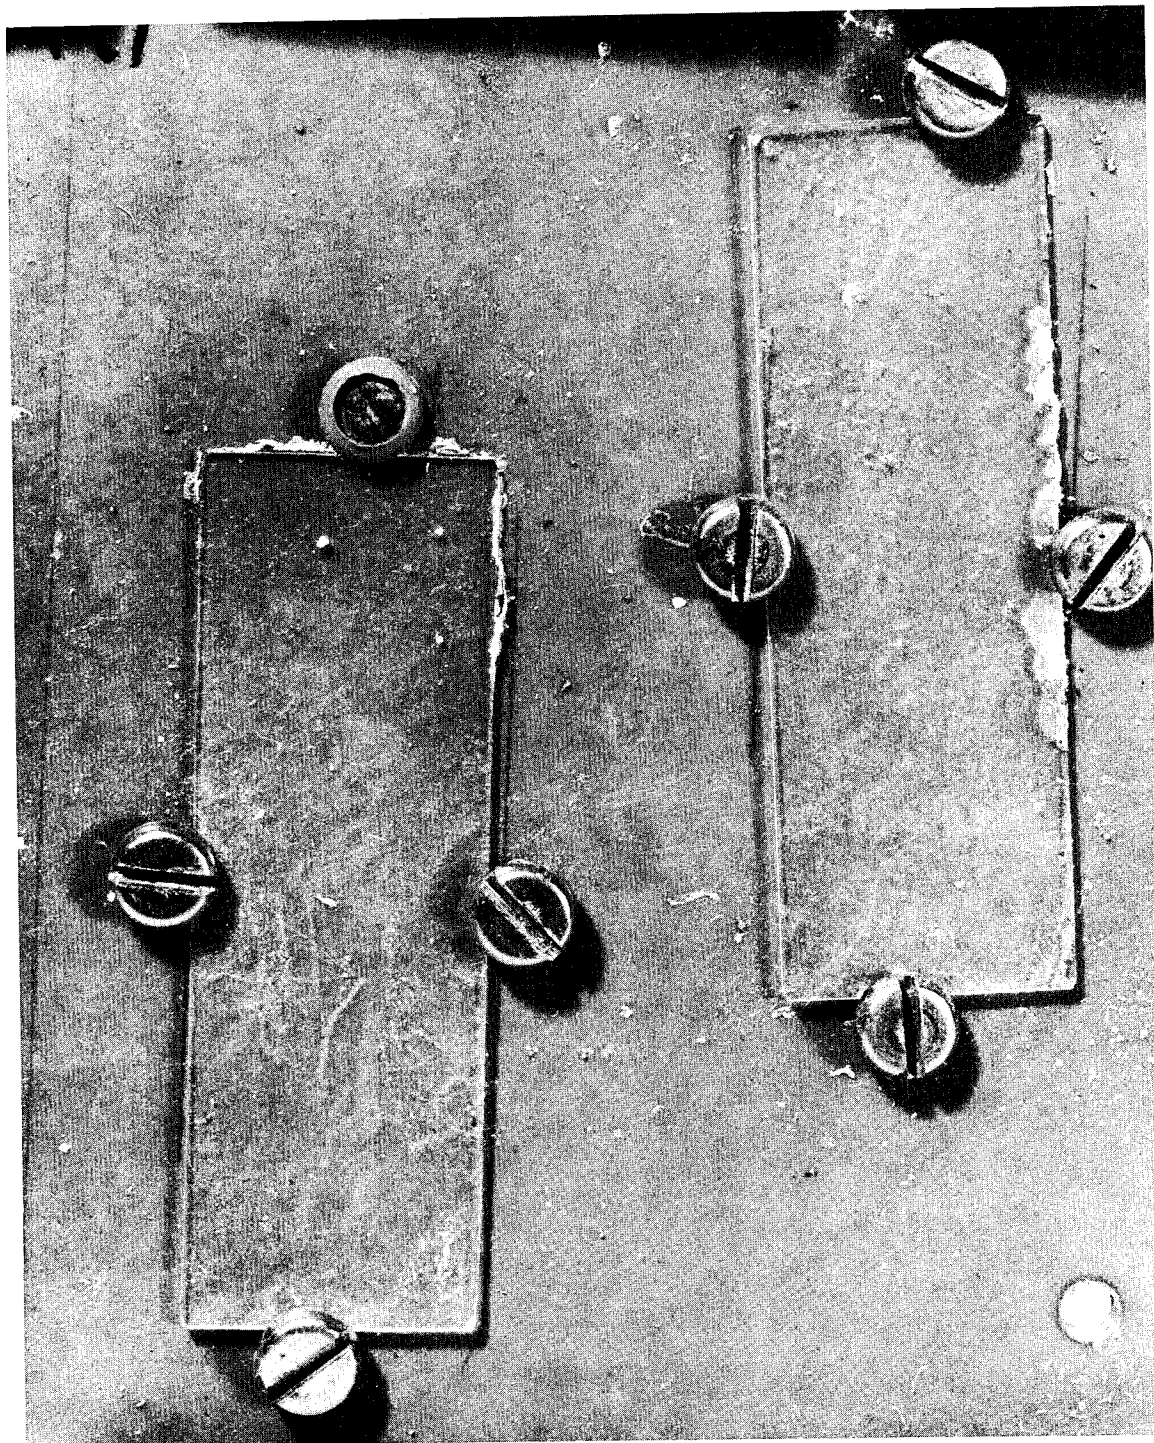
Glass Microscope Slides. Except for some microbial forms and hydroid growth over the surface of the glass, microscopic examination revealed no visible effects of etching or frosting by microorganisms (Figure 38). Photomicrographs of some of the deep sea microbial forms found on the glass are shown in Figures 39 and 40.

Figure 38. Microscope slides attached to a phenolic laminated sheet.
